FAILURE ANALYSIS AND PRELIMINARY CORRECTIVE ACTION WORK PLAN

**AVERY LANDING SITE
AVERY, IDAHO**

**Submitted by:
Farallon Consulting, L.L.C.
320 3rd Avenue Northeast
Issaquah, Washington 98027
Farallon PN: 496-001**

March 17, 2006

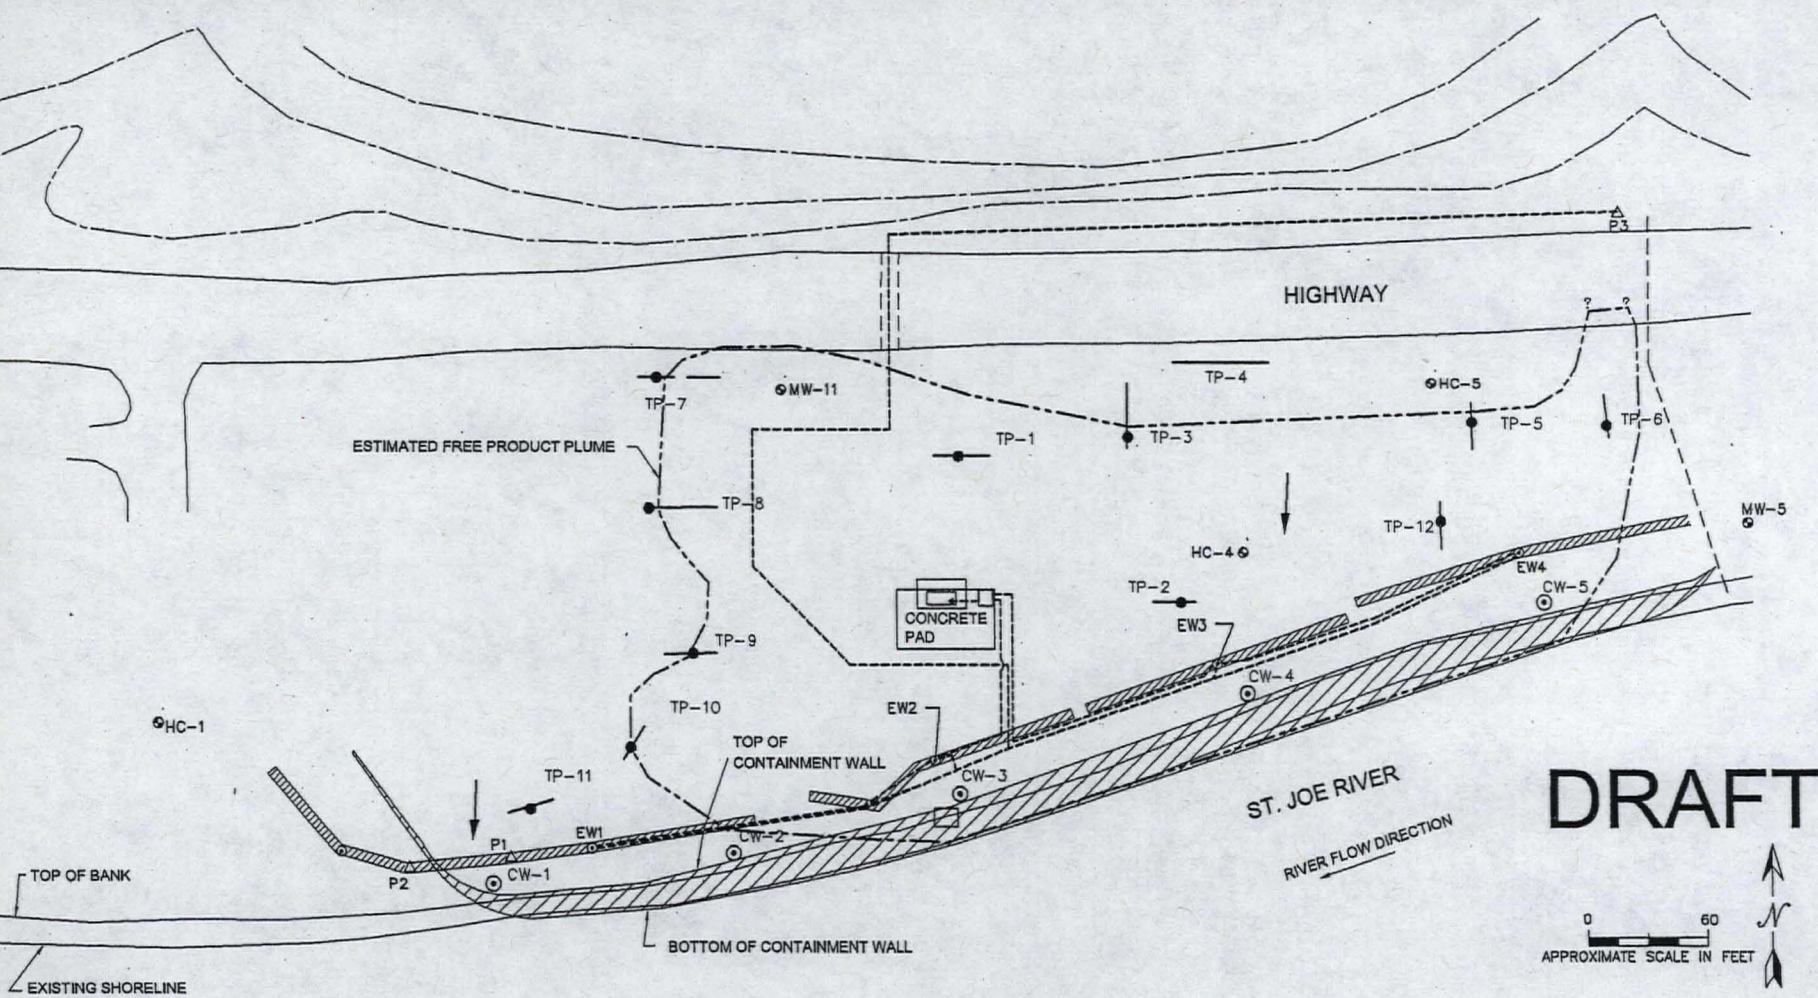
FIGURE 3
SITE PLAN
AVERY LANDING
AVERY, IDAHO

The LNAPL removal system did not fully mitigate the migration of LNAPL into the St. Joe River; therefore, Potlatch decided to install a containment wall along the river bank. Approximately 650 linear feet of the St. Joe River bank was excavated and a PVC liner was installed from the top of the bank to below the surface water level in the summer of 2000. Figure 3 depicts the installation area.
